ASBESTOS INSPECTION REPORT

**Former Wesco Distribution Inc.
1803 Eoff Street
Wheeling, Ohio County, West Virginia**

Triad Project No. 04-15-0603

November 17, 2015

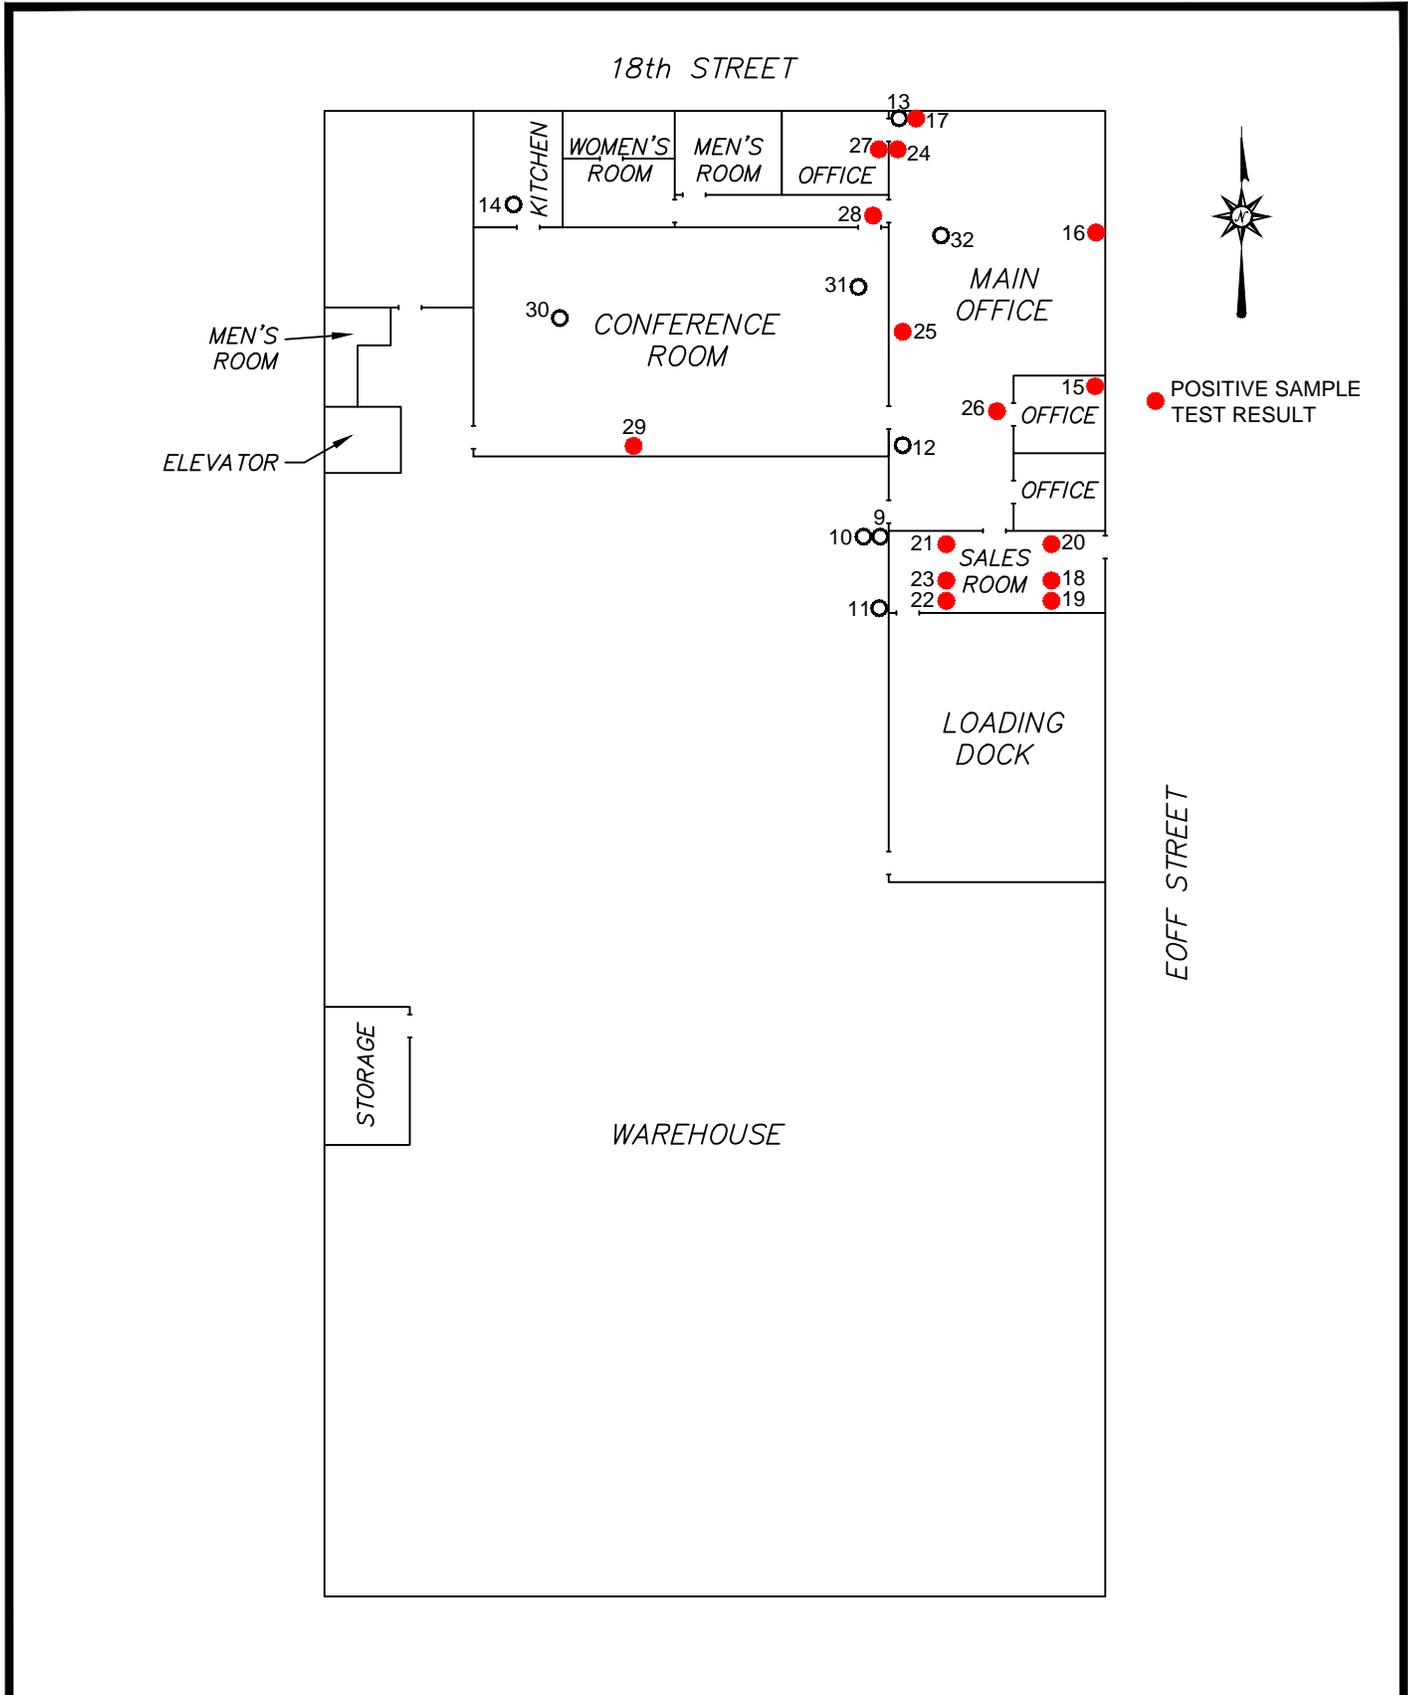
PROJECT No.: 04-15-0603 FIGURE No.: 1

FORMER WESCO FACILITY ASBESTOS INSPECTIONS
 1803 EOFF STREET
 WHEELING, OHIO COUNTY, WV
FIRST FLOOR

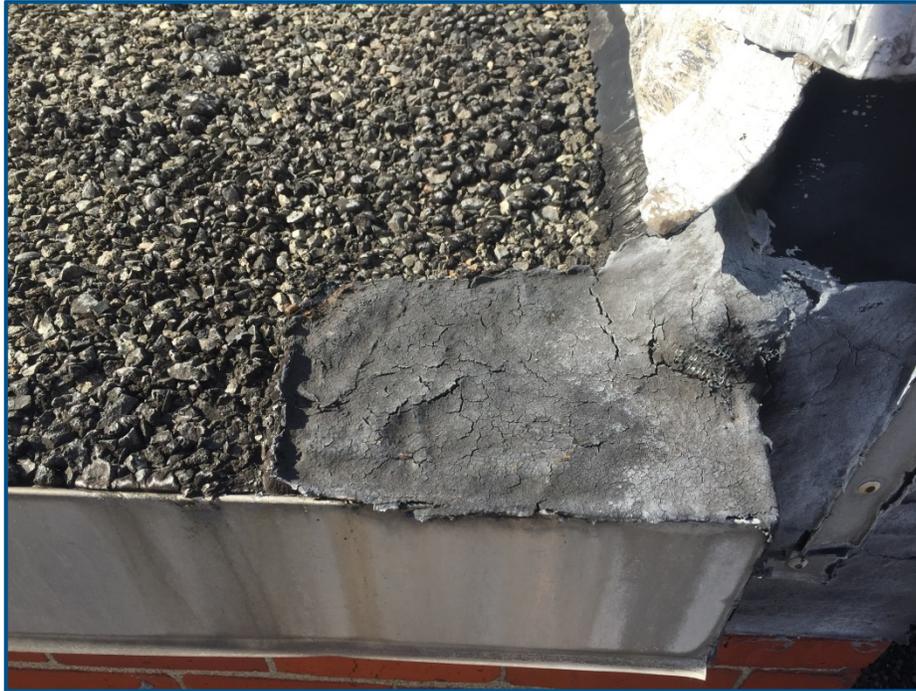
PEC LAB #:	CLIENT ID #:	LOCATION:	COLOR:
15WB-17505	S-01	Main Roof	Black
Texture/Description:	Solid/Roofing - Rolled	Chrysotile: 0%	Tremolite: 0% Anthophyllite: 0%
TOTAL ASBESTOS:	0 %	Amosite: 0%	Actinolite: 0% Crocidolite: 0%
Cellulose: 2 %	Fiber Glass: 3%	Others: 0%	Filler/Binder: 95 %

PEC LAB #:	CLIENT ID #:	LOCATION:	COLOR:
15WB-17506	S-02	Main Roof	Black
Texture/Description:	Solid/Roofing - Rolled	Chrysotile: 0%	Tremolite: 0% Anthophyllite: 0%
TOTAL ASBESTOS:	0 %	Amosite: 0%	Actinolite: 0% Crocidolite: 0%
Cellulose: 18 %	Fiber Glass: 0%	Others: 0%	Filler/Binder: 82 %

PEC LAB #:	CLIENT ID #:	LOCATION:	COLOR:
15WB-17507	S-03	Main Roof	Black
Texture/Description:	Solid/Roofing - Rolled	Chrysotile: 0%	Tremolite: 0% Anthophyllite: 0%
TOTAL ASBESTOS:	0 %	Amosite: 0%	Actinolite: 0% Crocidolite: 0%
Cellulose: 20 %	Fiber Glass: 0%	Others: 0%	Filler/Binder: 80 %

PEC LAB #:	CLIENT ID #:	LOCATION:	COLOR:
15WB-17508	S-04	Main Roof	Black
Texture/Description:	Solid/Roofing - Rolled	Chrysotile: 0%	Tremolite: 0% Anthophyllite: 0%
TOTAL ASBESTOS:	0 %	Amosite: 0%	Actinolite: 0% Crocidolite: 0%
Cellulose: 2 %	Fiber Glass: 3%	Others: 0%	Filler/Binder: 95 %

PEC LAB #:	CLIENT ID #:	LOCATION:	COLOR:
15WB-17509	S-05	Main Roof	Black
Texture/Description:	Solid/Roofing - Rolled	Chrysotile: 0%	Tremolite: 0% Anthophyllite: 0%
TOTAL ASBESTOS:	0 %	Amosite: 0%	Actinolite: 0% Crocidolite: 0%
Cellulose: 3 %	Fiber Glass: 3%	Others: 0%	Filler/Binder: 94 %

Photograph # 5
Roofing samples 1, 2, 3, 4 & 5.

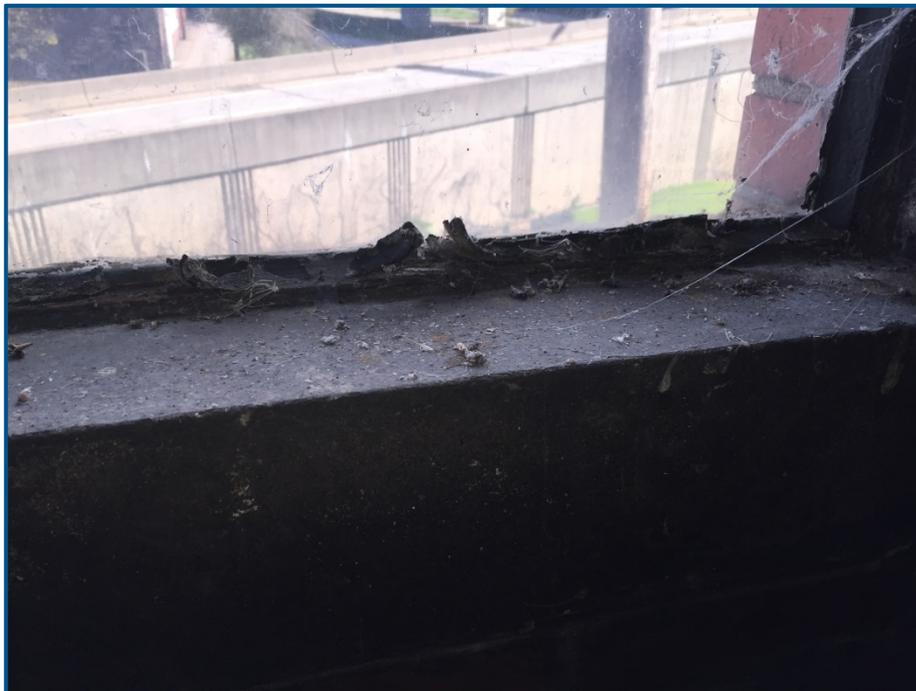
PEC LAB #:	CLIENT ID #:	LOCATION:	COLOR:				
15WB-17510	S-06	2nd Floor	Black/Grey				
Texture/Description:	Solid/Window Glazing	Chrysotile:	3%	Tremolite:	0%	Anthophyllite:	0%
TOTAL ASBESTOS:	3 %	Amosite:	0%	Actinolite:	0%	Crocidolite:	0%
Cellulose:	0 %	Fiber Glass:	0%	Others:	0%	Filler/Binder:	97 %

PEC LAB #:	CLIENT ID #:	LOCATION:	COLOR:				
15WB-17511	S-07	2nd Floor	Grey				
Texture/Description:	Solid/Window Glazing	Chrysotile:	3%	Tremolite:	0%	Anthophyllite:	0%
TOTAL ASBESTOS:	3 %	Amosite:	0%	Actinolite:	0%	Crocidolite:	0%
Cellulose:	0 %	Fiber Glass:	0%	Others:	0%	Filler/Binder:	97 %

PEC LAB #:	CLIENT ID #:	LOCATION:	COLOR:				
15WB-17512	S-08	2nd Floor	Grey				
Texture/Description:	Solid/Window Glazing	Chrysotile:	3%	Tremolite:	0%	Anthophyllite:	0%
TOTAL ASBESTOS:	3 %	Amosite:	0%	Actinolite:	0%	Crocidolite:	0%
Cellulose:	0 %	Fiber Glass:	0%	Others:	0%	Filler/Binder:	97 %

Photograph # 6
2nd floor window glazing samples 6, 7 & 8.

Laboratory analysis of building material samples collected from the 1803 Eoff Street structure positively identified asbestos containing materials. Caution should be exercised when working with these materials. Abatement or encapsulating of these materials should be completed prior to any demolition or remodeling. Such work should be performed by an asbestos abatement contractor, licensed by the State of West Virginia.

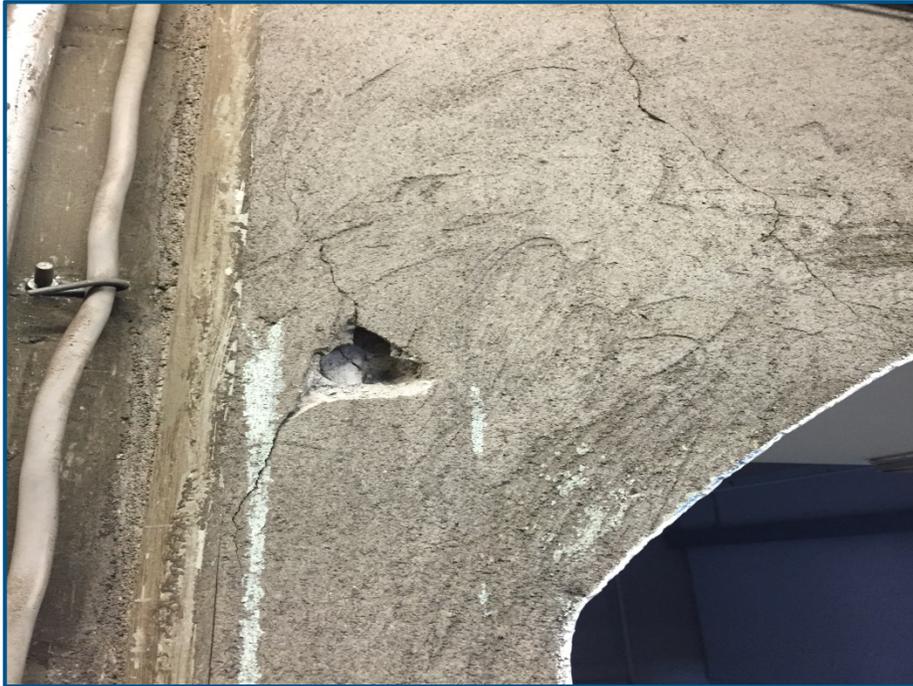
PEC LAB #:	CLIENT ID #:	LOCATION:	COLOR:				
15WB-17513	S-09	1st Floor	Grey				
Texture/Description:	Solid/Cement Wall Covering	Chrysotile:	0%	Tremolite:	0%	Anthophyllite:	0%
TOTAL ASBESTOS:	0 %	Amosite:	0%	Actinolite:	0%	Crocidolite:	0%
Cellulose:	0 %	Fiber Glass:	0%	Others:	0%	Filler/Binder:	100%

PEC LAB #:	CLIENT ID #:	LOCATION:	COLOR:				
15WB-17514	S-10	1st Floor	Grey				
Texture/Description:	Solid/Cement Wall Covering	Chrysotile:	0%	Tremolite:	0%	Anthophyllite:	0%
TOTAL ASBESTOS:	0 %	Amosite:	0%	Actinolite:	0%	Crocidolite:	0%
Cellulose:	2 %	Fiber Glass:	0%	Others:	0%	Filler/Binder:	98 %

PEC LAB #:	CLIENT ID #:	LOCATION:	COLOR:				
15WB-17515	S-11	1st Floor	Grey				
Texture/Description:	Solid/Cement Wall Covering	Chrysotile:	0%	Tremolite:	0%	Anthophyllite:	0%
TOTAL ASBESTOS:	0 %	Amosite:	0%	Actinolite:	0%	Crocidolite:	0%
Cellulose:	0 %	Fiber Glass:	0%	Others:	0%	Filler/Binder:	100%

Photograph # 7
Cement wall covering samples 9, 10 & 11.

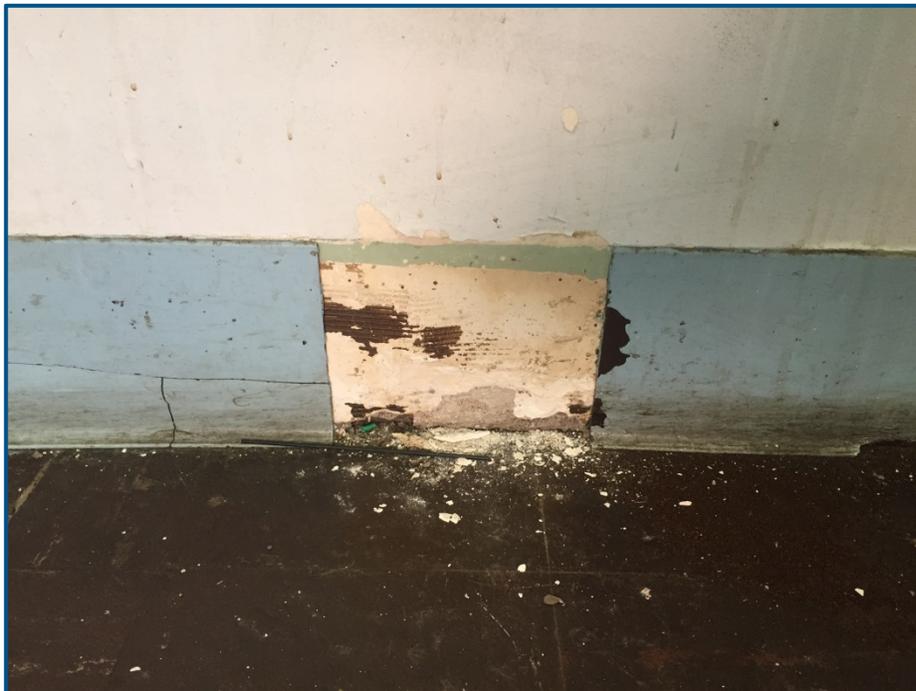
Photograph # 8
Wall plaster samples 12, 13 & 14.

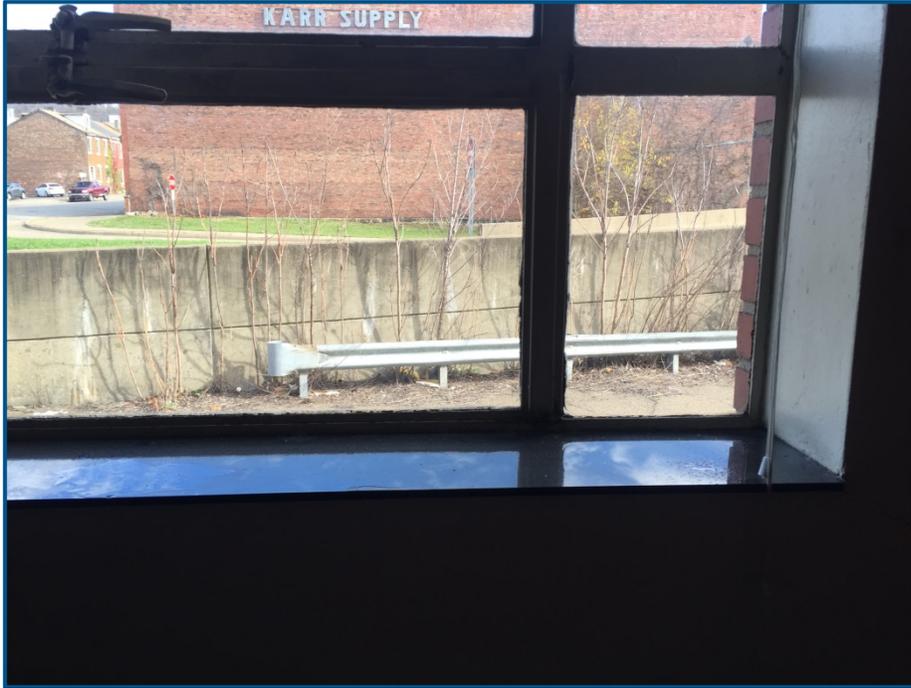
PEC LAB #:	CLIENT ID #:	LOCATION:	COLOR:
15WB-17519	S-15	1st Floor	White/Grey
Texture/Description:	Solid/Window Glazing	Chrysotile: 3%	Tremolite: 0% Anthophyllite: 0%
TOTAL ASBESTOS:	3 %	Amosite: 0%	Actinolite: 0% Crocidolite: 0%
Cellulose: 0 %	Fiber Glass: 0%	Others: 0%	Filler/Binder: 97 %

PEC LAB #:	CLIENT ID #:	LOCATION:	COLOR:
15WB-17520	S-16	1st Floor	White/Grey
Texture/Description:	Solid/Window Glazing	Chrysotile: 2%	Tremolite: 0% Anthophyllite: 0%
TOTAL ASBESTOS:	2 %	Amosite: 0%	Actinolite: 0% Crocidolite: 0%
Cellulose: 0 %	Fiber Glass: 0%	Others: 0%	Filler/Binder: 98 %

PEC LAB #:	CLIENT ID #:	LOCATION:	COLOR:
15WB-17521	S-17	1st Floor	White/Grey
Texture/Description:	Solid/Window Glazing	Chrysotile: 2%	Tremolite: 0% Anthophyllite: 0%
TOTAL ASBESTOS:	2 %	Amosite: 0%	Actinolite: 0% Crocidolite: 0%
Cellulose: 0 %	Fiber Glass: 0%	Others: 0%	Filler/Binder: 98 %

Photograph # 9
1st floor window glazing samples 15, 16 & 17.

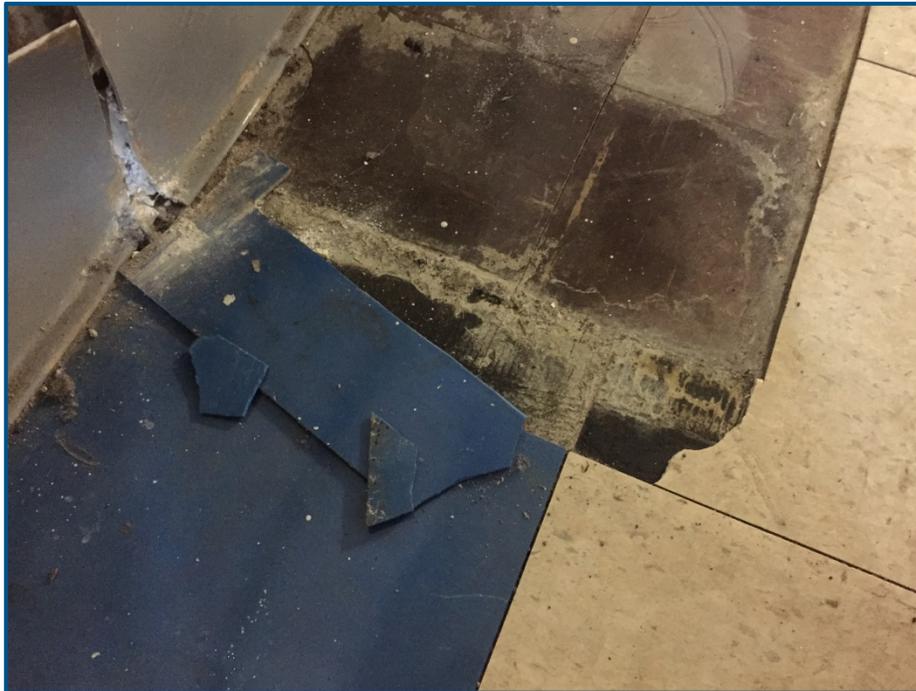
Photograph # 10
Blue and cream colored floor tile samples 18, 19, 20, 21, 22 & 23.

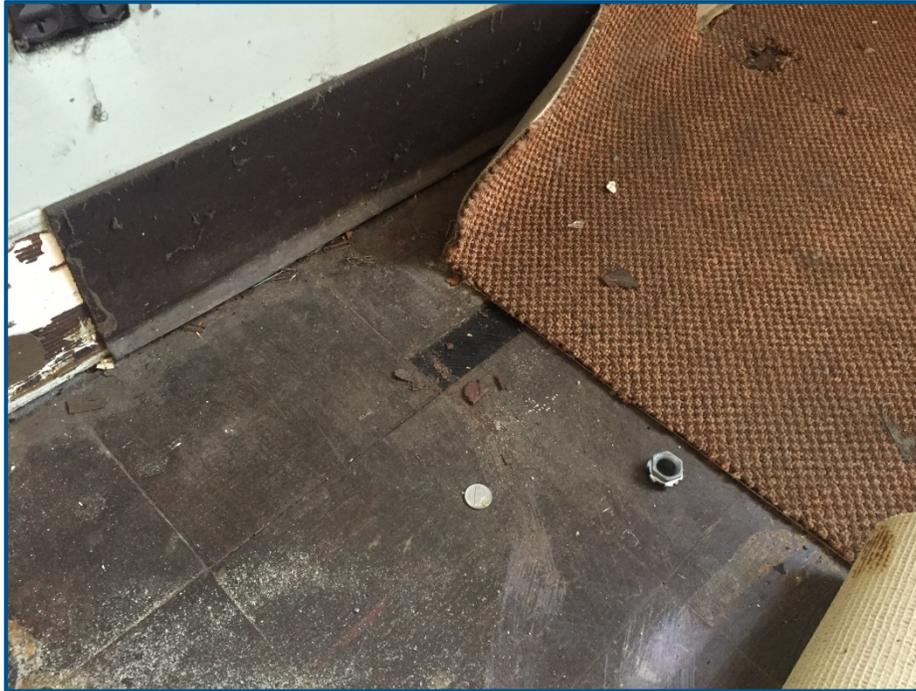
PEC LAB #:	CLIENT ID #:	LOCATION:	COLOR:
15WB-17528a	S-24	1st Floor	Brown
Texture/Description:	Solid/9x9 Floor Tile	Chrysotile: 3%	Tremolite: 0% Anthophyllite: 0%
TOTAL ASBESTOS:	3 %	Amosite: 0%	Actinolite: 0% Crocidolite: 0%
Cellulose: 0 %	Fiber Glass: 0%	Others: 0%	Filler/Binder: 97 %

PEC LAB #:	CLIENT ID #:	LOCATION:	COLOR:			
15WB-17529a	S-25	1st Floor	Brown			
Texture/Description:	Solid/9x9 Floor Tile		Chrysotile: 3%	Tremolite: 0%	Anthophyllite: 0%	
TOTAL ASBESTOS:	3 %		Amosite: 0%	Actinolite: 0%	Crocidolite: 0%	
Cellulose: 0 %	Fiber Glass: 0%		Others: 0%	Filler/Binder: 97 %

PEC LAB #:	CLIENT ID #:	LOCATION:	COLOR:			
15WB-17530	S-26	1st Floor	Brown			
Texture/Description:	Solid/9x9 Floor Tile		Chrysotile: 3%	Tremolite: 0%	Anthophyllite: 0%	
TOTAL ASBESTOS:	3 %		Amosite: 0%	Actinolite: 0%	Crocidolite: 0%	
Cellulose: 0 %	Fiber Glass: 0%		Others: 0%	Filler/Binder: 97 %

Photograph # 11
Dark 9"x 9" floor tile samples 24, 25 & 26.

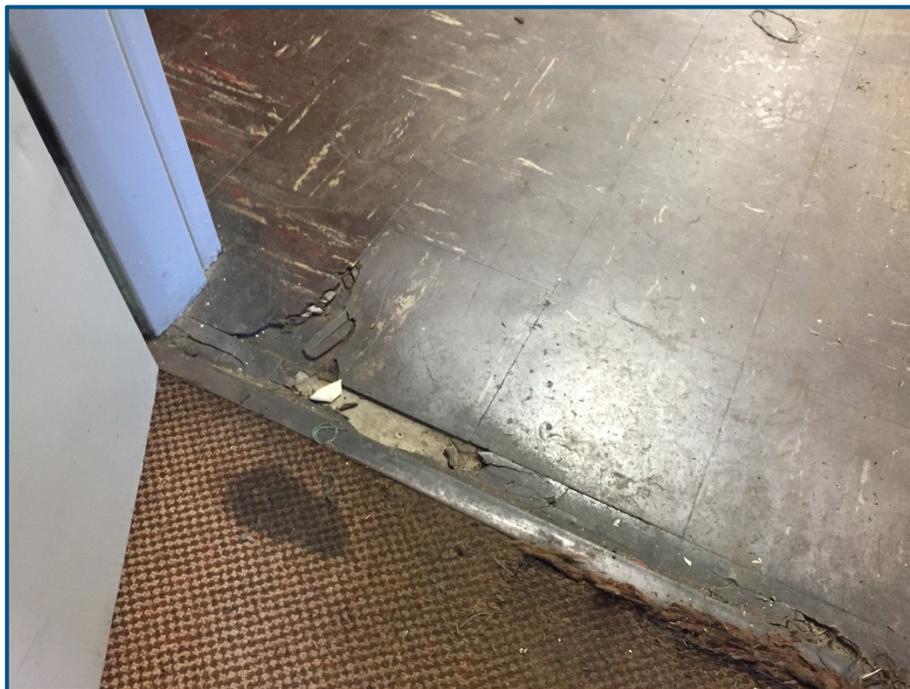
PEC LAB #:	CLIENT ID #:	LOCATION:	COLOR:			
15WB-17531a	S-27	1st Floor	Red			
Texture/Description:	Solid/9x9 Floor Tile		Chrysotile: 3%	Tremolite: 0%	Anthophyllite: 0%	
TOTAL ASBESTOS:	3 %		Amosite: 0%	Actinolite: 0%	Crocidolite: 0%	
Cellulose: 0 %	Fiber Glass: 0%		Others: 0%	Filler/Binder: 97 %

PEC LAB #:	CLIENT ID #:	LOCATION:	COLOR:			
15WB-17532a	S-28	1st Floor	Red			
Texture/Description:	Solid/9x9 Floor Tile		Chrysotile: 3%	Tremolite: 0%	Anthophyllite: 0%	
TOTAL ASBESTOS:	3 %		Amosite: 0%	Actinolite: 0%	Crocidolite: 0%	
Cellulose: 0 %	Fiber Glass: 0%		Others: 0%	Filler/Binder: 97 %

Photograph # 12
Red 9"x 9" floor tile samples 27, 28 & 29.

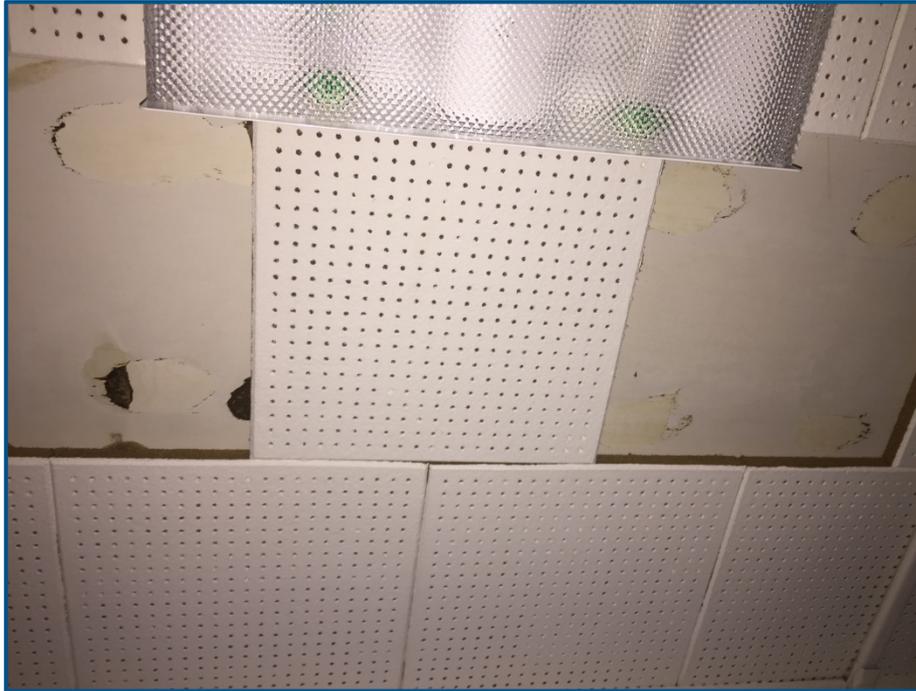
Photograph # 13
Acoustic ceiling tile samples 30, 31 & 32.
